# Campaign Service

**BULLETIN NUMBER:**  
CB19-N-002

## IMPORTANT SAFETY RECALL

**RELAY BOX INSPECTION – 19V-TBD**  
(Transport Canada 2019-TBD)

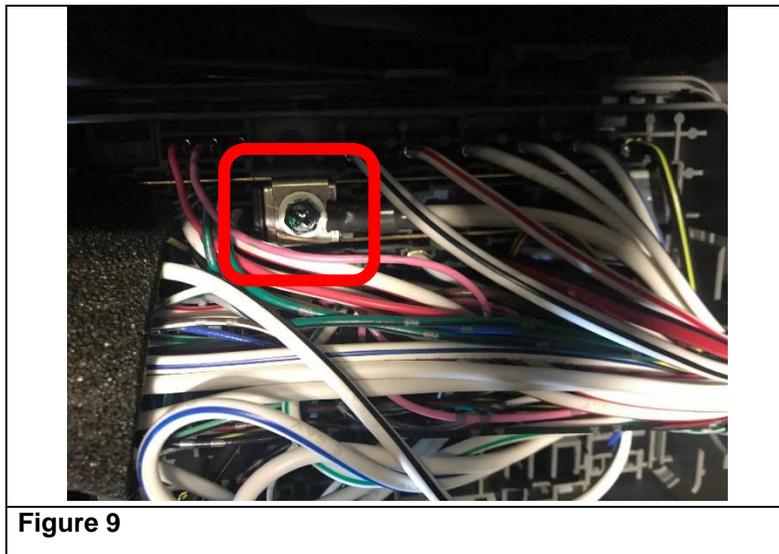
**Figure 9**

8. Inspect the condition of the relay box power wire. (See Figures 9 and 10 for OK condition.). Determine if there is any damage to the power wire and/or relay box:
  - a. If there is any damage, take a photo similar to Figure 9 and email it to [isuzuta@icta-us.com](mailto:isuzuta@icta-us.com). Then call the Isuzu Technical Assistance Line at 1-877-478-3828, Prompt 3 for further instructions. Document the TAL case number on the repair order. This will be required for claim submission.
  - b. If there is no evidence of damage from heat, continue to Step 9.
9. Inspect the wire terminal for excessive insulation. (See Figures 10 and 11.) If the insulation is OK, proceed to Step 11. If the insulation is Not OK, proceed to Step 10.

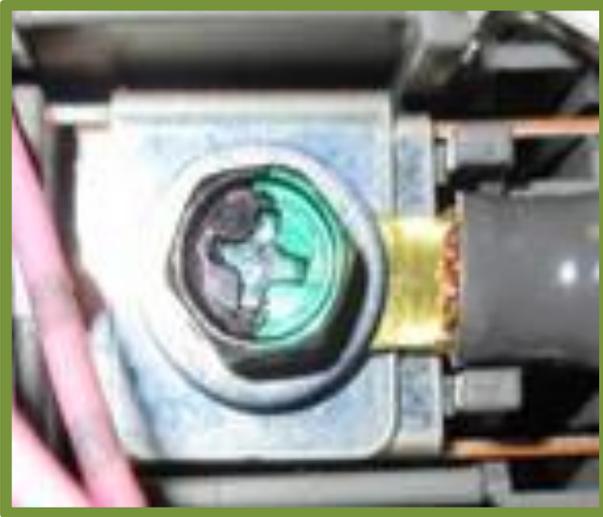
Figure 10 – OK Condition

11. Torque the power supply terminal bolt to the specified torque.  
**Tightening Torque:** 30.1 lb in. (3.4 Nm).
12. Reinstall the white inner fuse box cover.

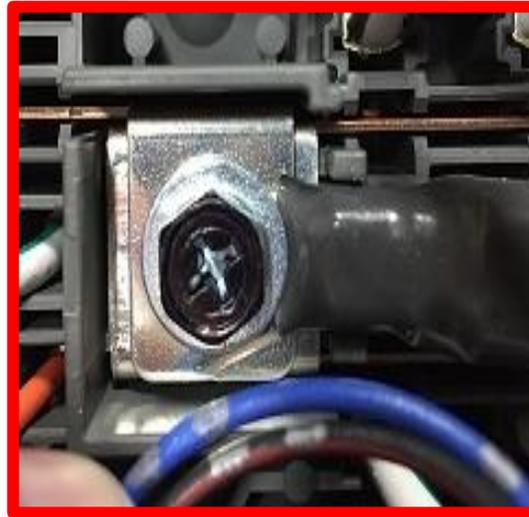
Figure 11 – Not OK Condition

10. Remove the terminal bolt and lift the terminal away from the fuse box. Using a razor blade, carefully trim away any excess insulation as necessary. Then reinstall the bolt.
