Preliminary Information

PIP5748C Particulate Matter Sensor Protection Tube Performance Diagnostic May Set A False DTC P1488

Brand:	Model:	Model Years:	VIN:		Engine:	Transmissions:
			from	to		
Chevrolet	Silverado	2020	ALL	ALL	LM2	All
GMC	Sierra	2020	ALL	ALL	LM2	All

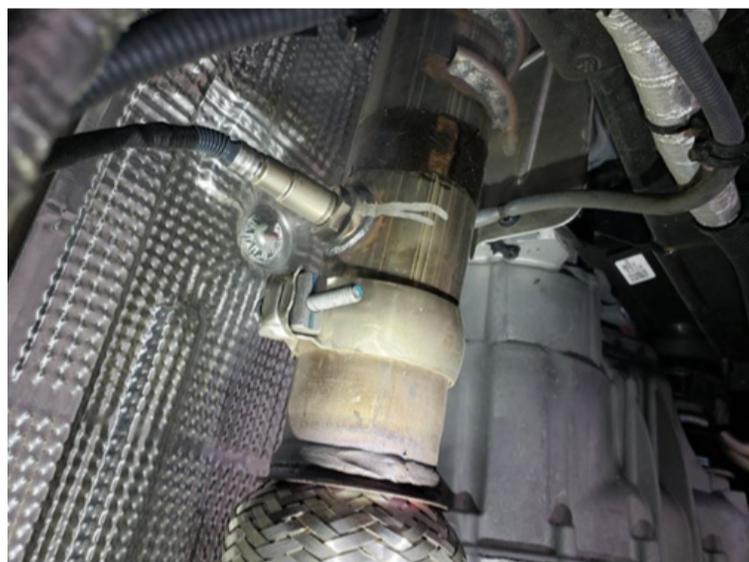
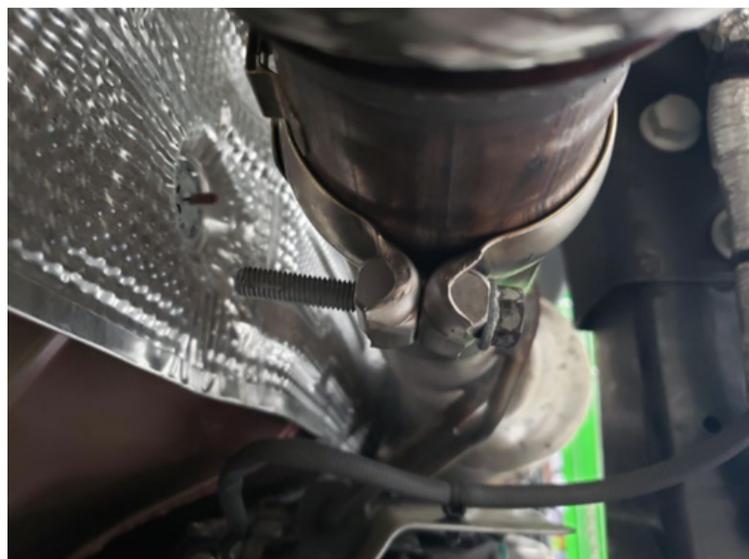
To test for leaks in the exhaust use the Power Smoke diagnostic leak detector (GE-52250 - refer to the latest version of [PIP5684](#)), but there are two important considerations. The smoke from the tester may not get through the DPF, so to test downstream of the DPF, administer the smoke downstream of the DPF. Also, the tailpipe sealing bladder doesn't reach the exhaust cooler so use duct tape around the pipe to seal the cooler holes. Repair any leaks as necessary but pay particular attention to the joint illustrated in the pictures below.

If this joint is leaking the clamp may have bottomed out before applying sufficient clamp load to the joint, or damage may have occurred from misalignment of the joint. Also, misalignment of the joint may contribute to the P1488 setting, even if the joint does not leak.

Separate the joint and check the witness marks for proper alignment. If the joint was found to be leaking, also inspect for deformations to either half of the joint and replace the components as necessary. If the clamp was found to be bottomed out, replace the clamp.

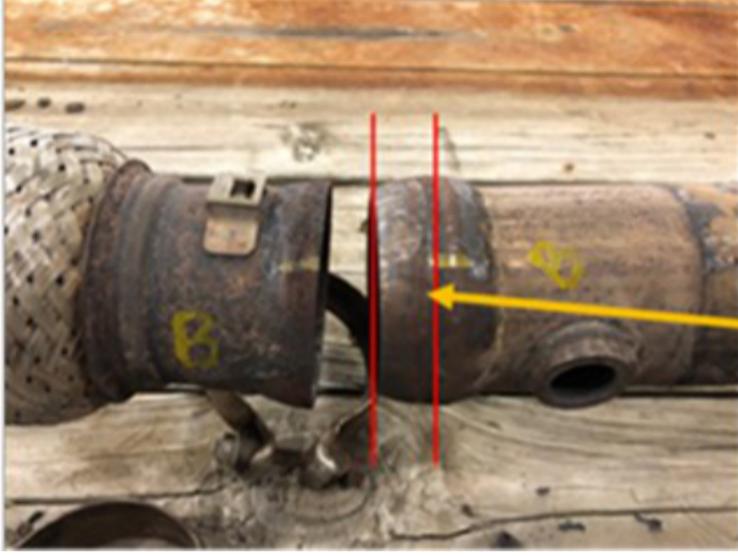
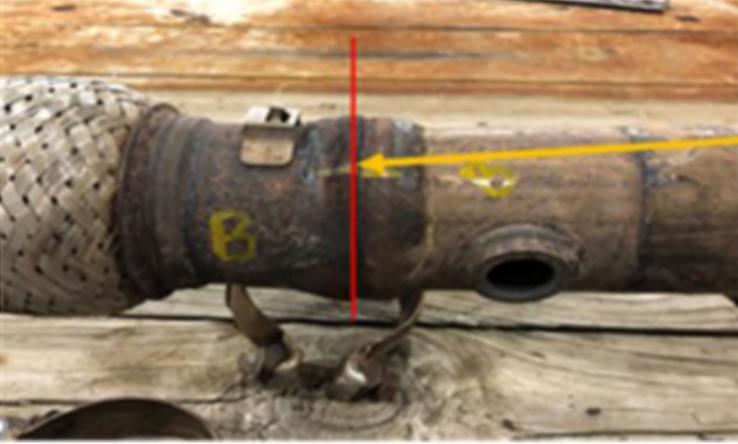
These witness marks indicate proper alignment

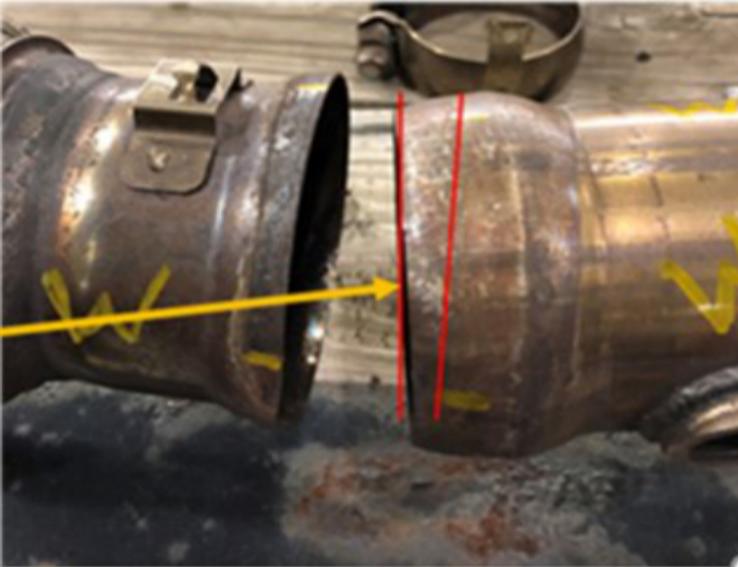
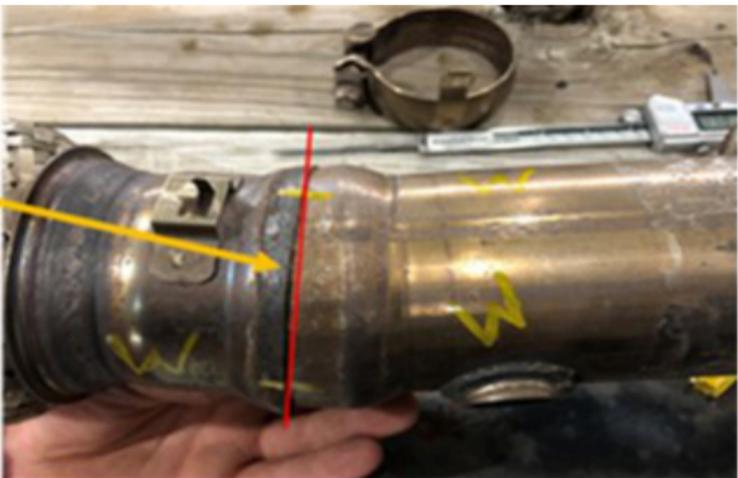
These witness marks indicate improper alignment
