# Campaign Service

**BULLETIN NUMBER:**  
CB19-N-002

## IMPORTANT SAFETY RECALL

**RELAY BOX INSPECTION – 19V-TBD**  
(Transport Canada 2019-TBD)

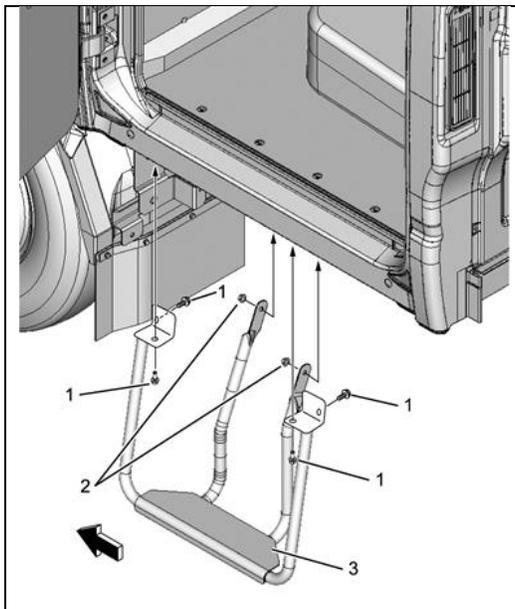
**Figure 1**

1. Bolt
2. Nut
3. Rear Step

1. Place the vehicle in park, apply the parking brake, and remove the key from the engine control switch.
2. Disconnect the negative battery cable.
3. If the vehicle is a crew cab model, remove the driver side rear step. (See Figure 1.) If the vehicle is a standard cab, proceed to the next step.
